# Unique Solutions for Repair of a Seawall and Lighthouse Structure

By Hamid Vossoughi

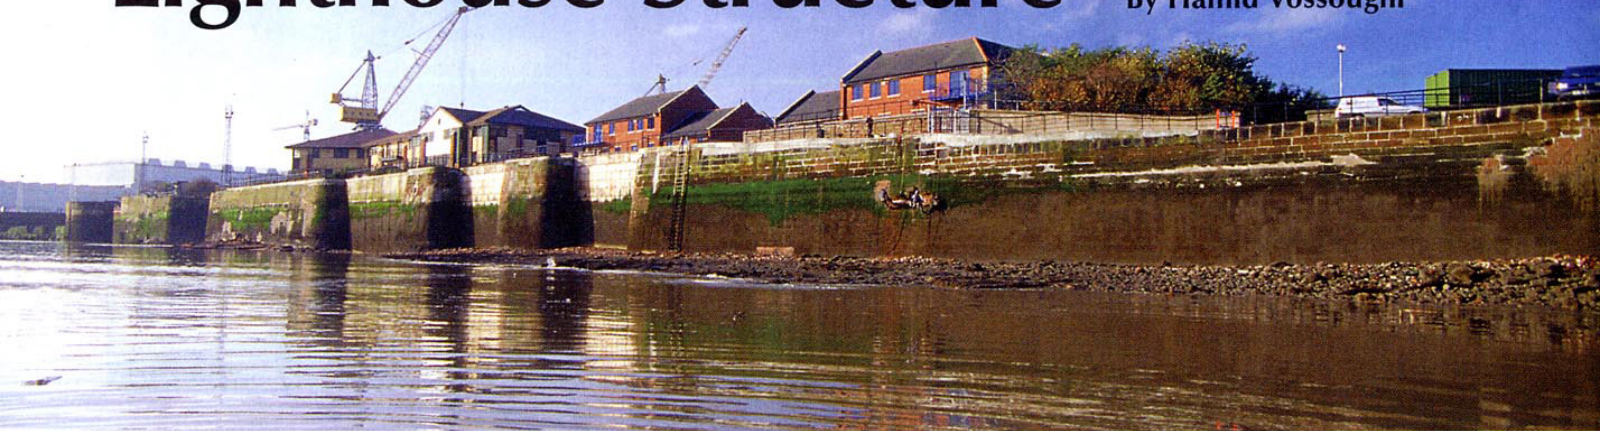
Figure 1: Priory Wharf seawall

**Seawall**—The seawall project site is the Priory Wharf and Pacific Road Seawall (Fig. 1), stretching over half a mile along the coastal line of the city of Birkenhead. The seawall is about 36 ft (11 m) high, with a recorded 27 ft (8.3 m) maximum tide. A pedestrian walkway separates the seawall from the densely populated residential properties beyond, overlooking the Liverpool skyline.

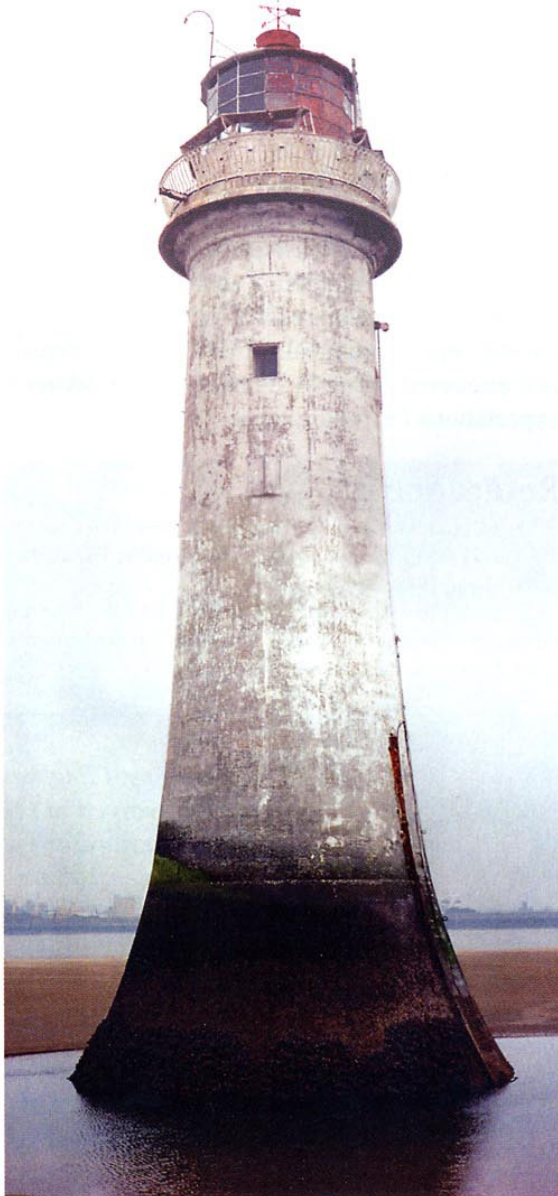
Figure 2: New Brighton lighthouse

**Lighthouse**—The lighthouse project site is the New Brighton Lighthouse (Fig. 2) at a location known as Perch Rock, overlooking the entrance to the Liverpool Harbor at the northernmost tip of Wirral, in the city of Wallasey. The lighthouse was rebuilt in 1827 after the original structure, built in 1683 on a wooden foundation, was damaged by ships and washed away. The lighthouse was the first built in the United Kingdom and is a listed historical structure. It is located about 700 ft (213 m) from a fort on the mainland and is accessible by

**Lighthouse**—The lighthouse is constructed with interlocking granite blocks and coated with a volcanic material forming a hard layer on the exterior surface of the blocks. With improvements in navigation technology, operation of the lighthouse was stopped in 1973 and the lighthouse has been neglected. The scope of work here included stripping of the various layers of delaminated coatings, crack repointing, and complete recoating of the lighthouse façade, totaling 5000 ft<sup>2</sup> (465 m<sup>2</sup>). The metal railing and lantern copper roof of the lighthouse was also stripped and painted.

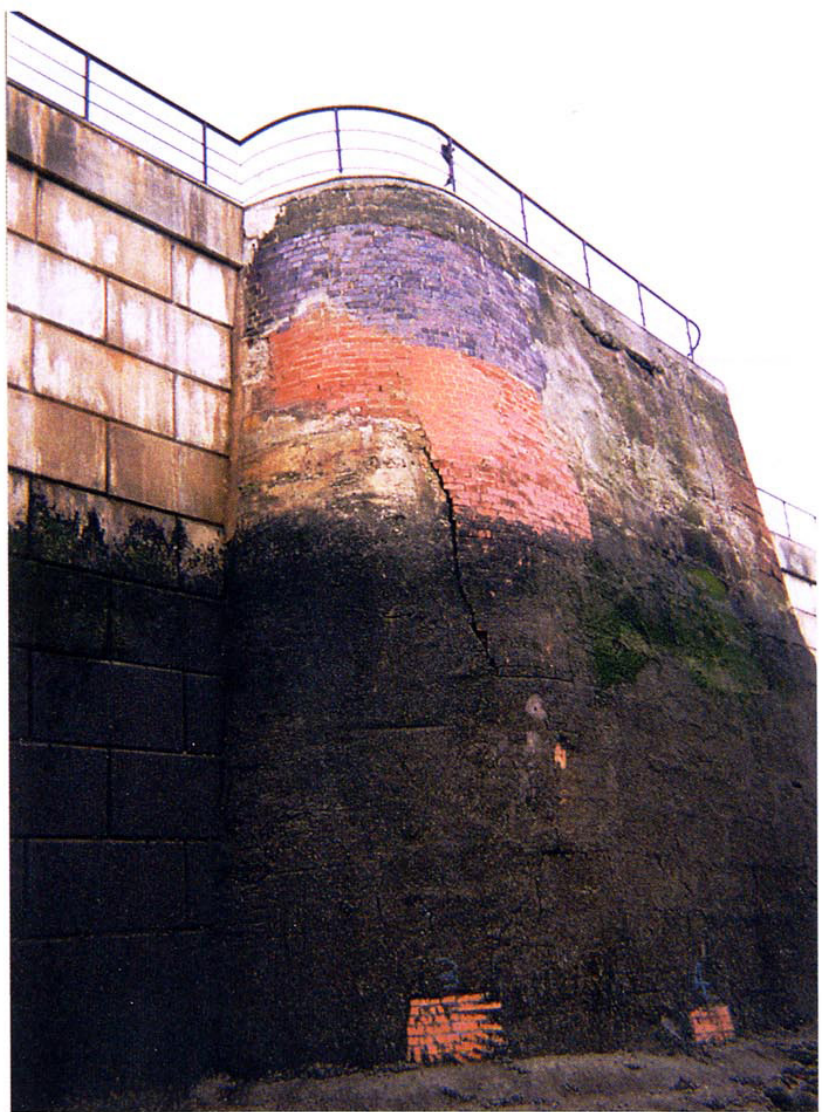
**Seawall**—The seawall is primarily constructed of sandstone blocks that are over 16 in. (40 cm) deep. The existing condition and distress in previously repaired areas (Fig. 3) was monitored and documented during low tides by town engineers. The scope of work included investigation of the existing conditions at 37 randomly located repair areas totaling 800 ft<sup>2</sup> (74 m<sup>2</sup>) and nondestructive testing with a boroscope to document the underlying condition of the wall. Following the investigation phase, the defective areas had to be replaced with new 8 in. (20 cm) thick matching sandstone blocks anchored to the backup, and the failed mortar joints in the rest of the repair areas had to be repointed.

Figure 3: Previously repaired area

**Seawall**—Our preliminary investigations identified hard grout backup and lack of anchorage between the previously repaired masonry and the backup. Demolition of the repaired areas required minimal effort, except at the larger areas where sequencing of the demolition and partial shoring was required. However, preparation of the backup, including removal of the randomly placed reinforcing

steel as wall anchorage, required more effort. The replacement stones, salvaged from a demolished structure; pre-bagged special repair mortar; and stainless steel anchors epoxied to the backup were used for the repair work. Stone blocks were lowered by a hoist and placed into position by the technicians (Fig. 6).

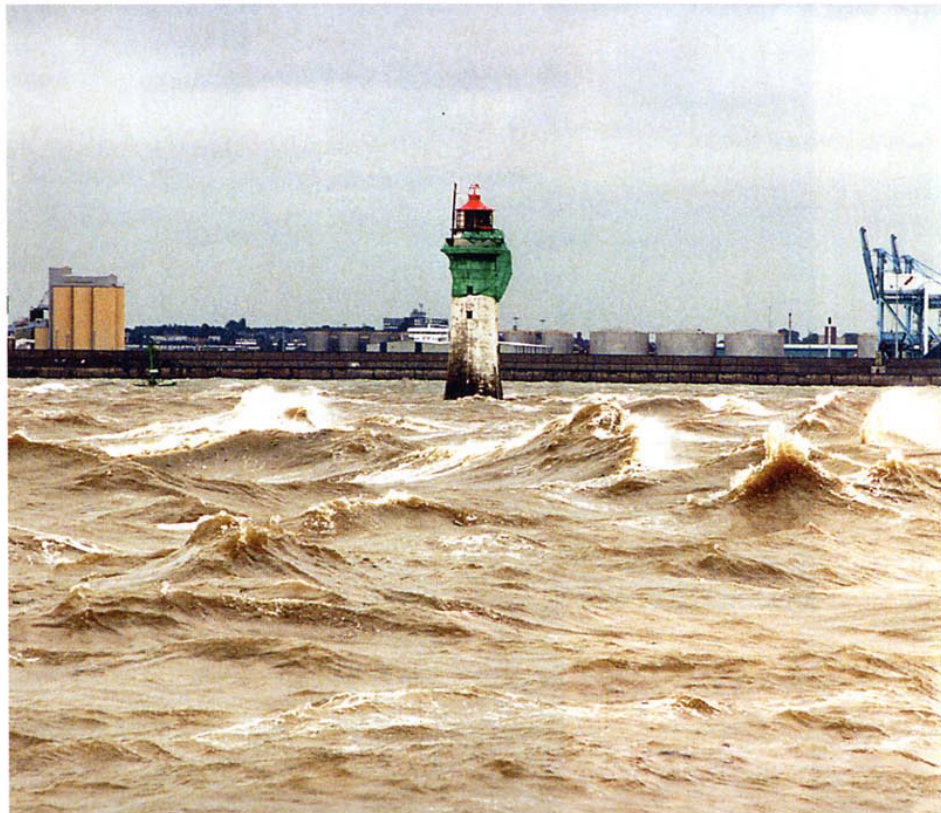
**Lighthouse**—The required scaffolding and other traditional means of access—extending to the base of the lighthouse, below the tide line, away from the shore (Fig. 4)—were deemed cost prohibitive.

Figure 4: Project site at high tide

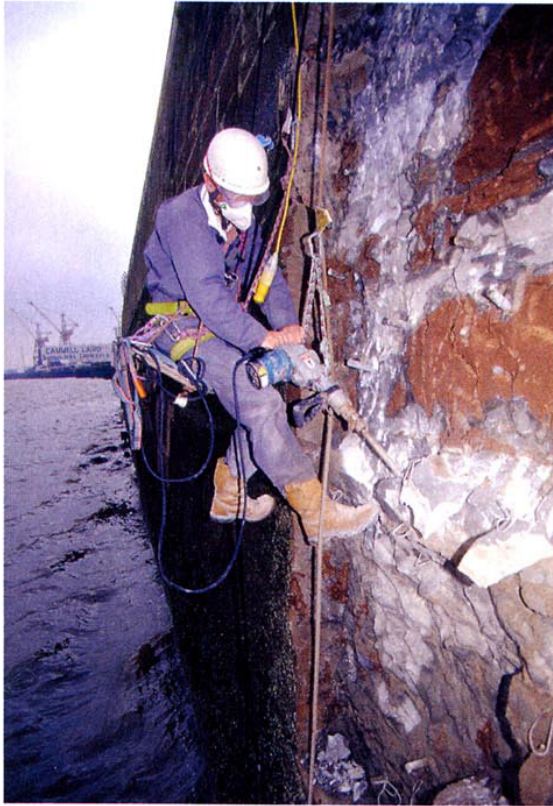
Figure 5: Technician utilizing Industrial Rope Access techniques

**Access Solutions**—The solution for access to both project sites was what is called Industrial Rope Access (Fig. 5). This technique combines specialized technical skills and equipment, originated in mountaineering and caving, and further developed for industrial use to safely access structures by descending and ascending, as well as laterally maneuvering on suspended or tensioned ropes. Using a double rope system, each with separately redundant secured anchors, in combination with full body harness, a technician is fully supported in tension or suspension in such a way that fall from height is prevented or restricted. Use of a seat

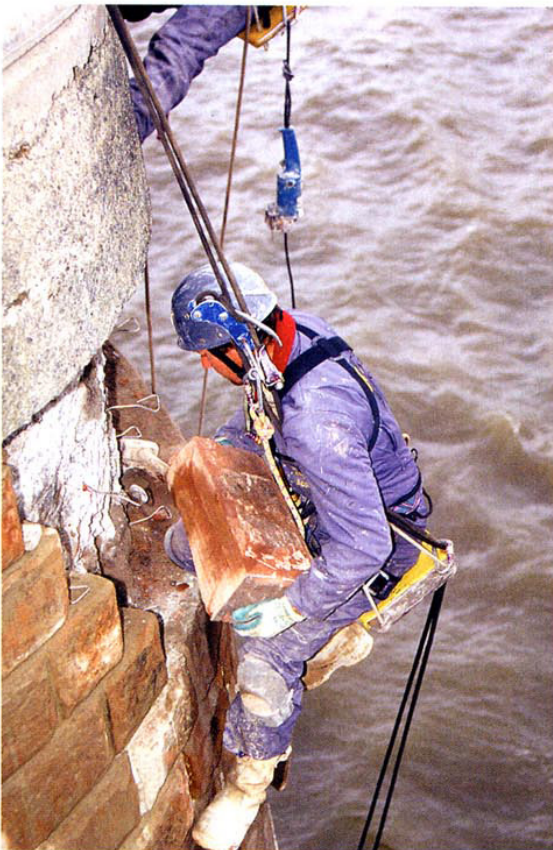
Figure 6: Rebuilding of the seawall

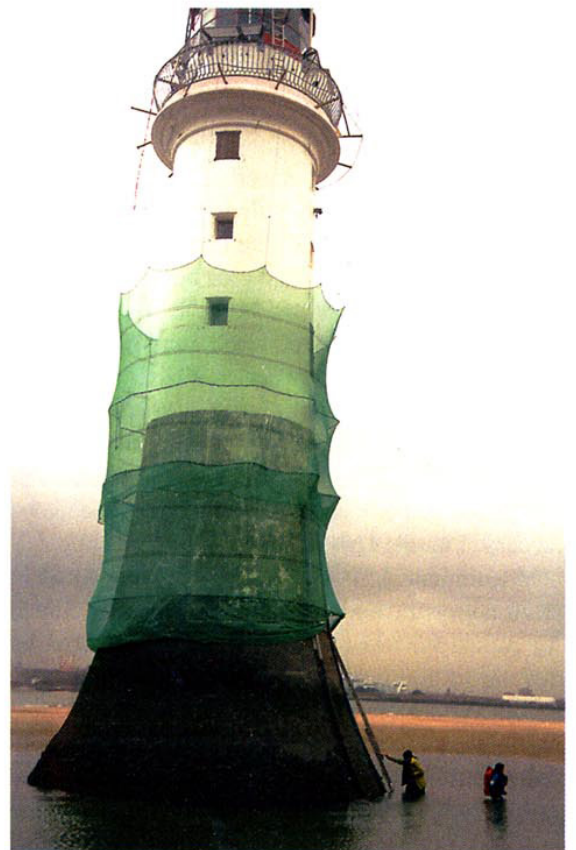
Figure 7: Containment net positioning

**Lighthouse**—Due to environmental requirements for containing the debris, the lighthouse was shrouded with containment netting (Fig. 7), draped similar to a curtain with steel rings to effectively position the netting along the height of the structure. The delaminated coating was power-washed, stored, and disposed of. Stripping and coating of the lighthouse was performed in five segments. Cracks and uneven surfaces were prepared with pumpable quick-set repair mortar, and minimal patching and dutchman repair of the blocks was required. Silane-based coating was used to coat the surface of the lighthouse (Fig. 8).

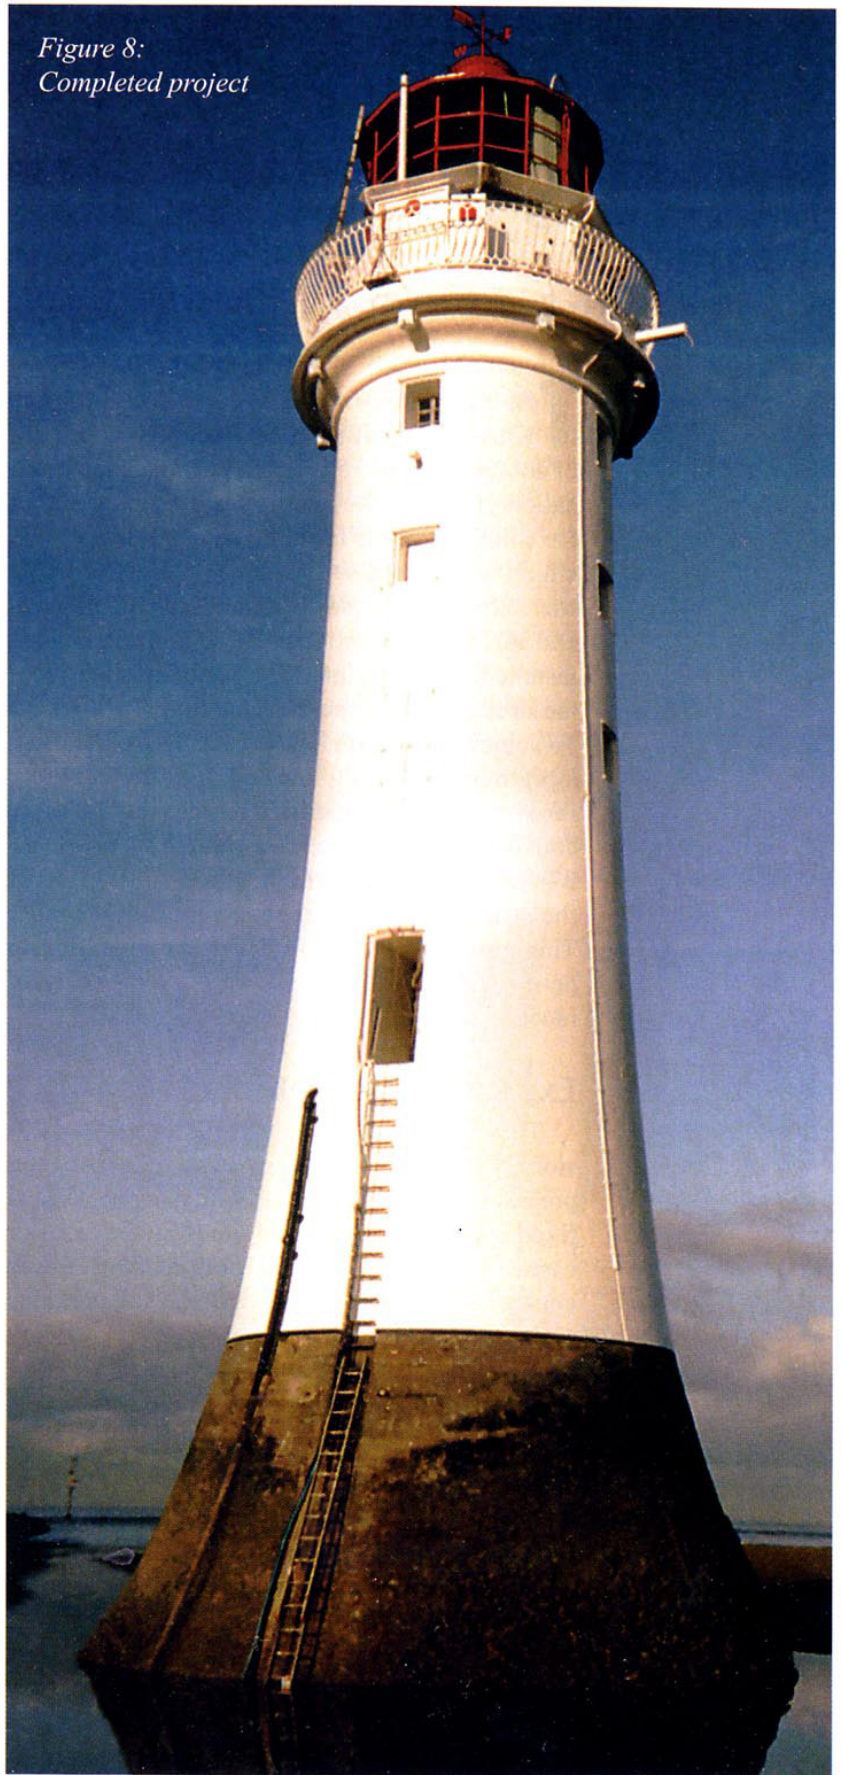
Figure 8:  
Completed project
