Industrial Rope Access – An Alternate Means for Inspection, Maintenance, and Repair of Building Facades and Structures

Reference: Vossoughi, H. and Siddiqui, R. I., “**Industrial Rope Access – An Alternate Means for Inspection, Maintenance, and Repair of Building Facades and Structures,**” *Building Facade Maintenance, Repair, and Inspection, ASTM STP 1444*, J. L. Erdley and T. A. Schwartz, Eds., ASTM International, West Conshohocken, PA, 2003.

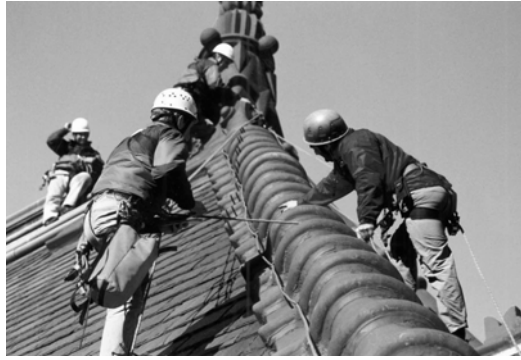
Figure 2 - Case Study 1

The scope of work was to perform a detailed condition assessment of the various steep roofs of a historic building with complex geometries, 80-m above the street level. Conventional means of access such as pipe staging would have made the investigation cost prohibitive. Rope Access provided the engineers (Figure 2) ease of access, as well as an economical, flexible, and versatile, hands-on evaluation of the roof structure.

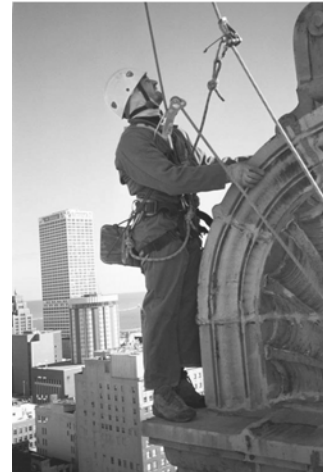
Figure 3 - Case Study 2

The project budget and requirements imposed a preliminary condition assessment of the exterior facade of an historic building occupying an entire city block, with a 110-m tall bell tower, in a short duration. The Rope Access solution allowed engineers to inspect about 20% of the building facade hands-on (Figure 3) in a period of three days. Using conventional means of access would have taken considerably longer at greater expense, and access to the bell tower would not have been practical.

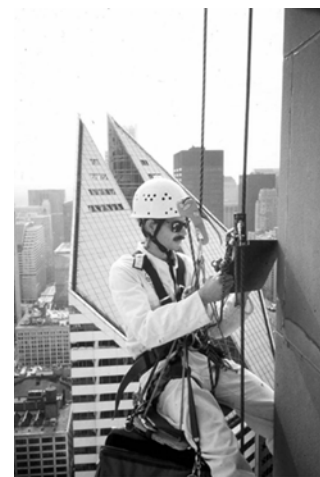
Figure 4 – Case Study 3

Rope Access facilitated a successful hands-on inspection (Figure 4) of defects on the exterior facade of a 185-m tall building. Existing house rigs were not operational, and the mast-climbing scaffolding, installed for the facade repairs, could not be operated due to a city-wide ban on the use of these platforms. Rope Access was also used to perform weld inspections on the radio antenna above the same building, 265-m above the ground, and perform the interior inspection of the 185-m chimney liner in the building. The antenna and chimney inspections were performed over a weekend to minimize down time to the radio antenna and the building's heating system.

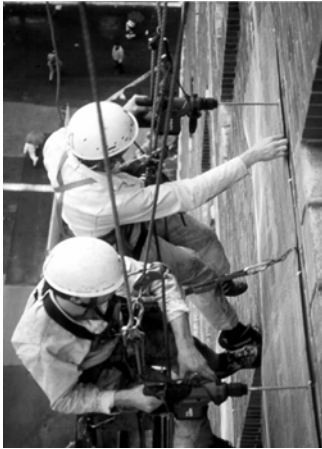
Figure 5 – Case Study 4

Initially, hands-on inspection of the exterior facade of a 12-story tall, ornamental and historic building occupying an entire city block was completed in four days utilizing Rope Access. Deteriorated conditions of the exterior facade and potential vibration damage from the adjoining construction activity made the need for emergency stabilization of the facade a necessity. Excavation at two sides of the building, a deep wood-framed cornice and lack of proper tie-backs prevented the use of scaffolding, boom truck, or lifts for the repairs. Rope Access technicians implemented the engineers' emergency stabilization and temporary repairs (Figure 5) (removing loose debris, stitching, netting, and banding displaced and cracked masonry) economically and efficiently.

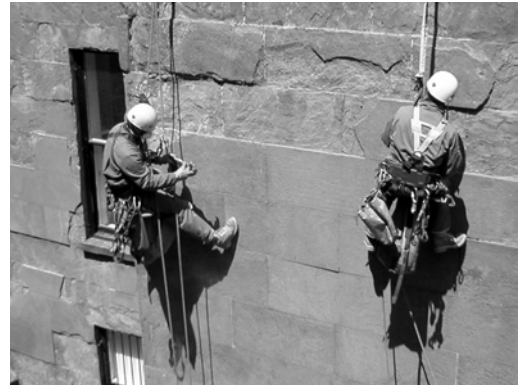
Figure 6 – Case Study 5

The building, located in an historic section of the city, is five stories and about 25-m tall with a mansard roof. The exterior walls are load-bearing masonry faced on the exterior with brownstone and brick. During a condition survey of the exterior building envelope, engineers identified loose and incipient spalls in the brownstone on the two street elevations and to the rear of the building. Under direction of the engineers, Rope Access technicians performed a hands-on inspection and removed loose and incipient spalls (Figure 6).

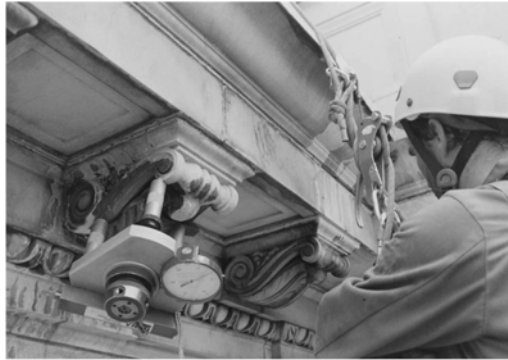
Figure 7 – Case Study 6

Rope Access technicians assisted the engineers with a condition assessment of the exterior facade of a museum over a period of four days. The condition assessment of the facade identified loose stone modillions below the vertical joint of the cornice. Because of the manicured grounds, safety, security and visual concerns, the client was adamant that technicians minimize the impact of the emergency repair activities on the museum.

Rope Access technicians removed loose modillions, and the balance of the modillions were anchored to the backup and load tested (Figure 7).

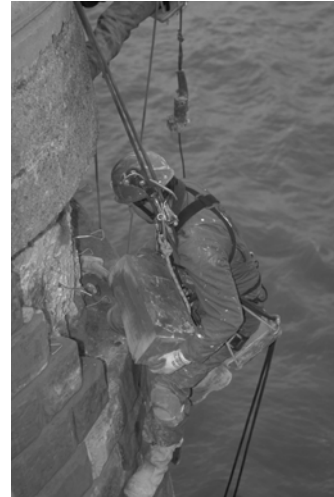
Figure 8 – Case Study 7

The scope of work on a 12-m high sea wall was removal of existing brick masonry repairs and replacement with matching brownstone block (Figure 8). The Rope Access technicians contended with changes in tides of up to 11-m (most of the work site was underwater at high tide), and using Rope Access techniques, the technicians had the ability to work with the rising and falling of the tide, quickly moving from lower to higher locations, and resuming work. All equipment and materials had to be removed from the site and contained in secure storage between shifts.
